METALS HANDBOOK

VOL. 9
FRACTOGRAPHY AND ATLAS OF FRACTOGRAPHY

8th EDITION

Fractography and Atlas of Fractographs

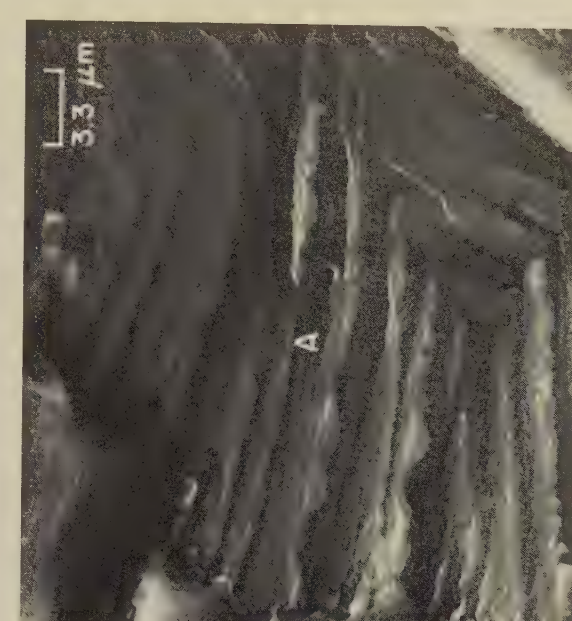
3000×

4056 Area outlined by the rectangle in 4055, as seen at triple the magnification there. Fatigue striations, which are about an order of magnitude smaller than the steplike formations, are faintly visible parallel with the edges of the "steps", as at area "A".

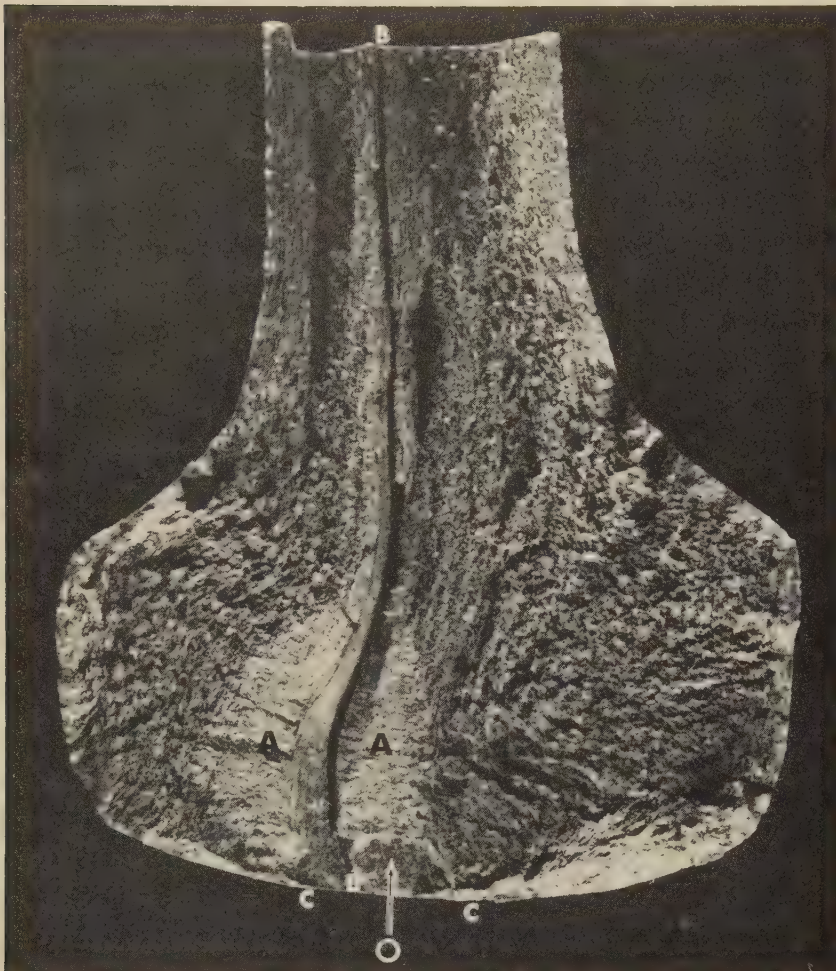
About $3\frac{1}{2}\times$

4057 Surface of a crack in an aircraft wing-spar carry-through forging of aluminum alloy 7075-T6. The crack was discovered during inspection after 5269 hr of service and was opened up. The external surface at edge C-C had been machined after forging. The regions marked "A" contain fatigue features that originated at a flaw (marked B-B) extending the full length of the segment. Area at "O" is shown enlarged in 4058. See also 4059 to 4064.

4058 An SEM view, at higher magnification, of the area at "O" in 4057. At left of the boundary (dark line running up from "A") is the surface of the flaw (B-B in 4057); at right of it is a fatigue surface ("A" at right in 4057). Note the beach marks just above mid-height in the fatigue surface (at arrows).

4059 A typical region in an area "A" of 4057. Fatigue striations that are nearly vertical (arrow) are faintly visible. These were found to be parallel to the flaw (B-B in 4057) in both "A" areas in 4057. Scattered dimples are evident in locations adjacent to the fatigue striations. See also 4060, at right.

4060 Highly magnified view of fatigue striations typical of those in areas "A" in 4057. In general, these striations were parallel with the flaw B-B. Dimples characterized the remainder of the fracture. Inclusions near the flaw suggested that it was the result of a pipe not cropped from the ingot.

4061 A region of the overload portion of the fracture in 4057 (opposite page). This region, which exhibits the dimples characteristic of ductile rupture, is representative of the entire fracture except for areas "A", and flaw B-B, in 4057. Scattered large dimples contain visible inclusions. See also 4062.

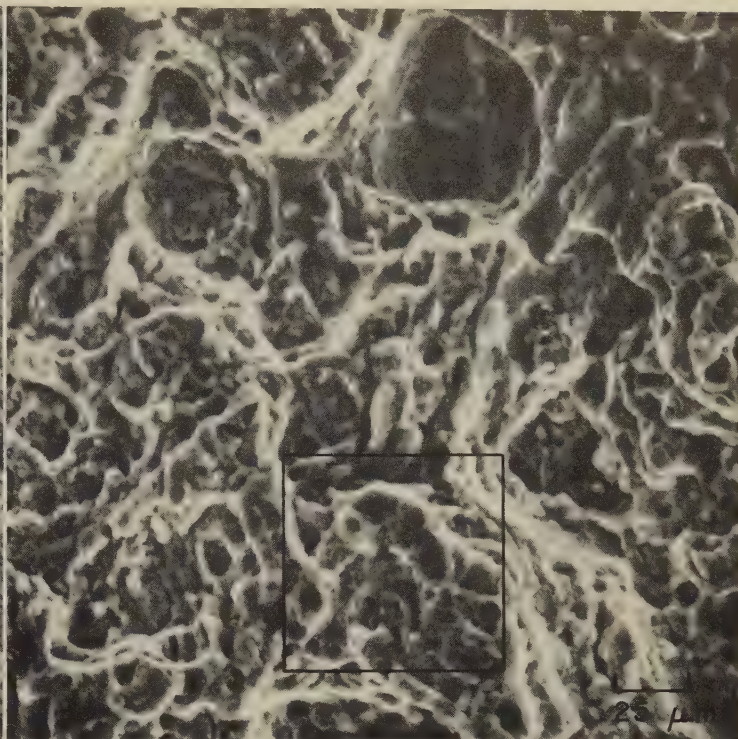
SEM fractograph

4062 Area outlined by the rectangle in fractograph 4061, as seen at five times the magnification there. Large dimples show the inclusions that initiated them; fine dimples that are too small to be resolved at this magnification exist among the large dimples. See also fractograph 4063 (below, at left).

4063 A view at still higher magnification of the area in the rectangle in 4062. The fine dimples can just be distinguished on the surfaces adjacent to the large dimples. Many alloy second-phase particles are discernible, although some are so deep within the dimples as to be nearly invisible. See also 4064.

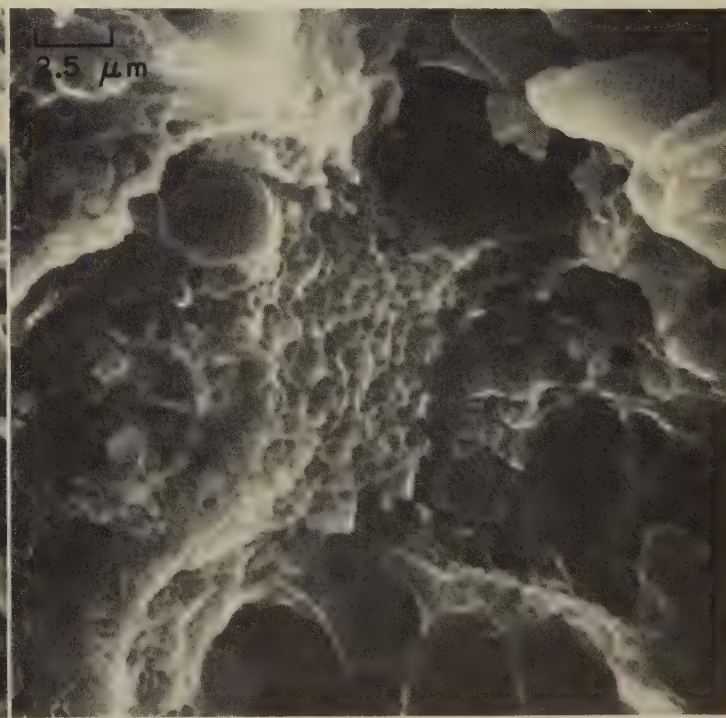
SEM fractograph

4064 A greatly magnified view of the fracture region in 4061, showing the area outlined by the rectangle in 4063. The region at center is made up of equiaxed dimples of quite uniform size. Note that several dimples are too deep for their bottoms to be lighted by an exposure proper for most of the dimples.

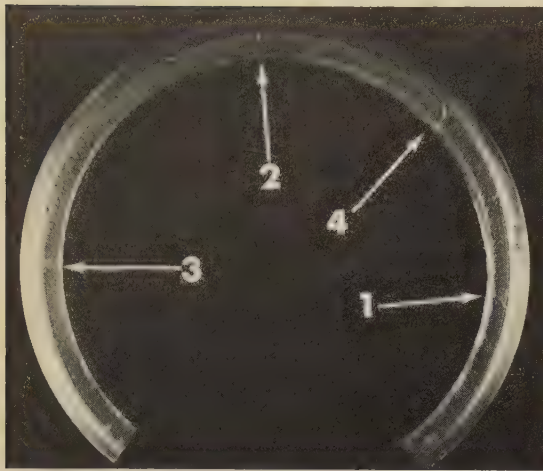
Photograph

4065 An aircraft shock-strut piston, of aluminum alloy 7075-T6, that fractured by fatigue in service. Hardness was Rockwell B 80. Numerals identify areas that received specific examination. See fractographs 4066 to 4076.

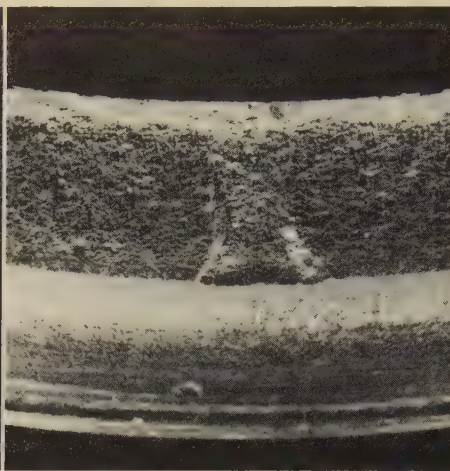
Light fractograph

4066 A larger, more detailed view of the fracture in 4065, at area 1. (A brief examination of area 2 of the fracture showed that it had virtually identical characteristics.)

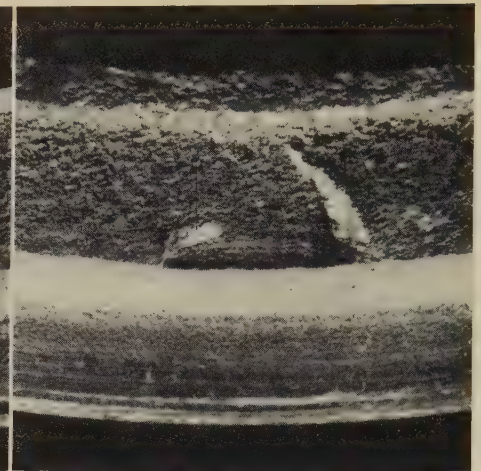
Light fractograph

4067 A magnified view of area 3 of the fractured piston in 4065. (Area 4 was also examined, and found to have equivalent characteristics.) More details of area 3 are shown in 4068 to 4076.

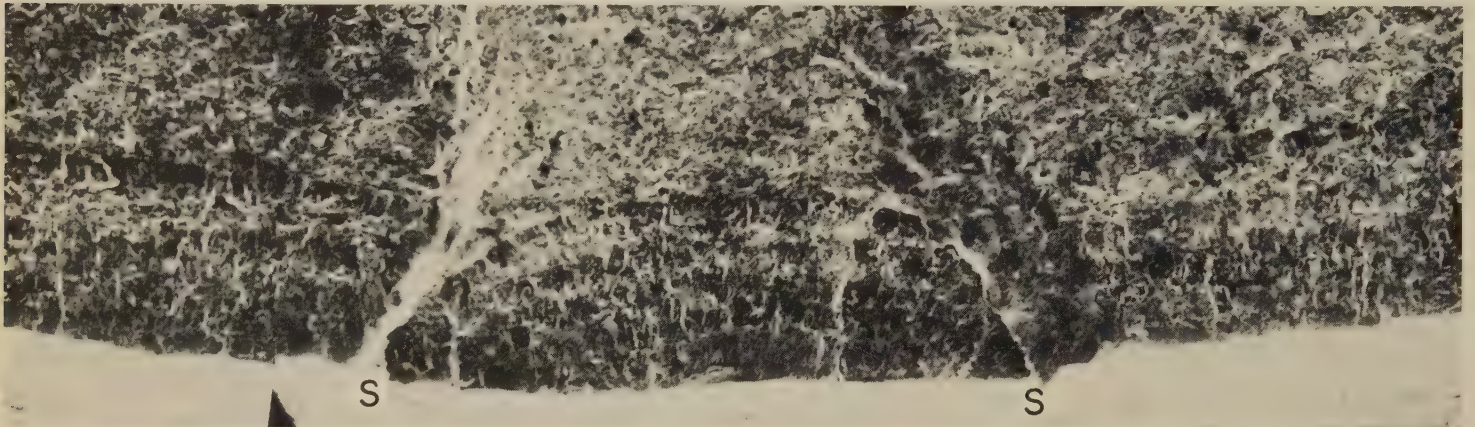
SEM fractograph (composite)

4068 This is a composite of four SEM views that were taken at the location of a suspected fatigue origin in area 3 of the piston fracture in 4065. (The location shown here lies at about the center of the view of area 3 shown in 4067.) The piston had been shot peened to provide compressive surface stresses as a protective measure against fatigue. The peened surface is at bottom in this view. The crescent-shaped area S-S was determined by stereo scrutiny to lie in a plane lower than the fracture face around it. The appearance of the edge of the fracture suggests that fatigue beach marks exist not only within the crescent but also on either side of it. See 4069, 4070.

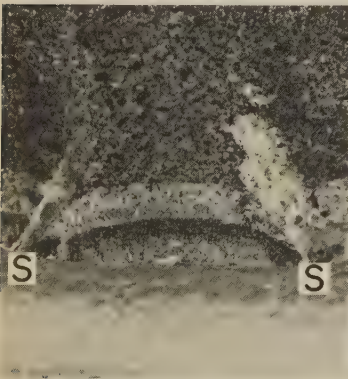
Light fractograph

4069 Area 3 of fracture in 4065, at a magnification intermediate between those of 4067 and 4068, showing definite marginal zones on either side of crescent (S-S).

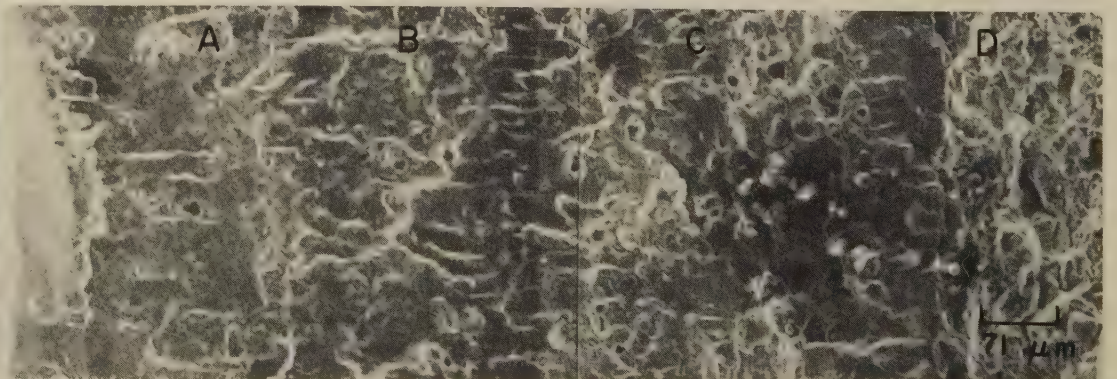
SEM fractograph (composite)

4070 A composite view of the center of the crescent marked S-S in fractograph 4068. Zone A corresponds to the lower light zone of the crescent in 4069, which is adjacent to the shot peened surface. The dark appearance of zone B here (and of same zone in 4069) is due to a film of contamination, which resisted all efforts at removal by ultrasonic cleaning. High magnification revealed fatigue striations in zone C. Zone D is the beginning of the final overload fast fracture. No specific cause of fracture initiation was found other than local areas of inadequate shot peening. See also 4071 to 4076.

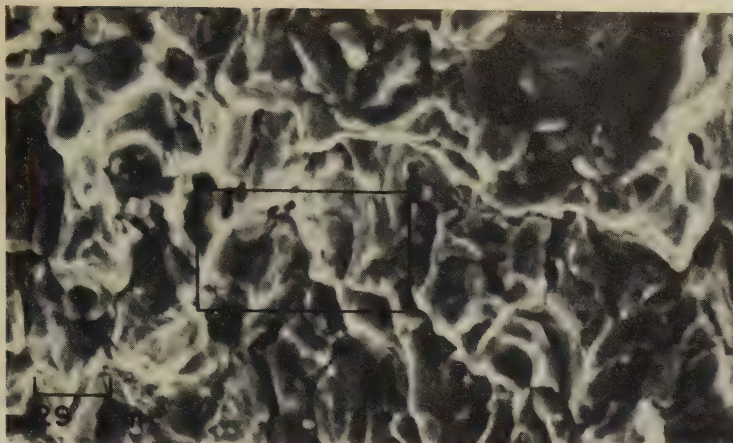
SEM fractograph

4071 Enlarged view of zone D in 4070, showing features that are typical of that region of final overload fast fracture. Many pores are visible that undoubtedly contained alloy second-phase particles earlier. The rectangle-outlined central region (shown enlarged in 4072) contains barely recognizable fine dimples.

4072 Area outlined by the rectangle in fractograph 4071 (left), as viewed at a higher magnification. Here, tiny dimples are resolved in the facets at upper center. These dimples are of a size very different from that of the large pores visible in the lower portion of the fractograph.

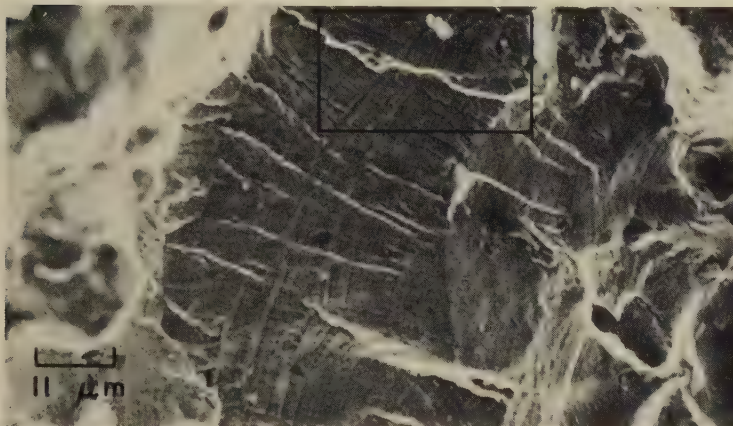
SEM fractograph

4073 View of zone C in 4070, showing fatigue striations. In general, lines drawn normal to the striations would point to the center of crescent S-S in 4068 and 4069 as the crack origin. Exceptions due to local grain orientations are also visible. Similar striations were on both sides of the crescent. See 4074.

4074 A view at higher magnification of the area in the rectangle in fractograph 4073. This shows the details of the fatigue striations present in zone C of 4070 much more clearly. Note the very small fatigue patches, separated by steps; the crack fronts of these patches merged again after a very few stress cycles.

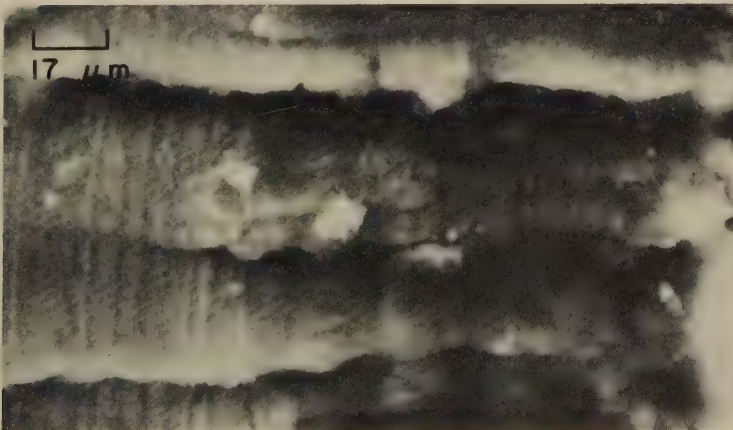
SEM fractograph

4075 A view of the fracture surface at the line of demarcation between zones B and C in fractograph 4070. Zone B is to the right here, and zone C is to the left. The film of contamination in zone B, which obscured essentially all the fatigue features, is very apparent. See also fractograph 4076, at right.

4076 View at another region at the demarcation between zones B and C in 4070, which is even more abrupt than in the view shown in fractograph 4075 (at left). It seems obvious that the source of the corrosion was suddenly eliminated, perhaps by a change of service, since there is no sign of any gradual transition.

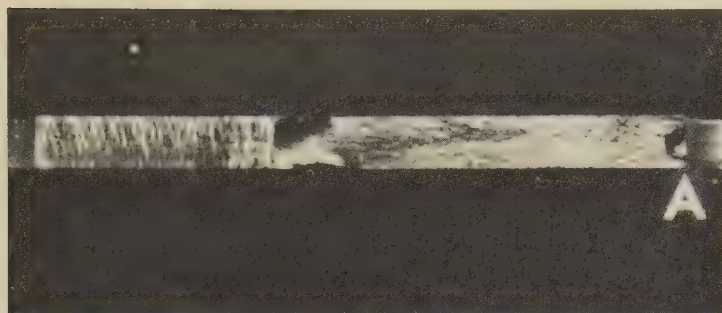
Light fractograph

4077 Fatigue-fracture surface of a bomb-rack side plate fabricated of aluminum alloy 7075-T6. Saw marks at left were made in opening up the fatigue crack for study. Crack origin was found to be at the edge of an attachment hole (marked "A", at right). See 4078 for a view of the area near "A" at five diameters.

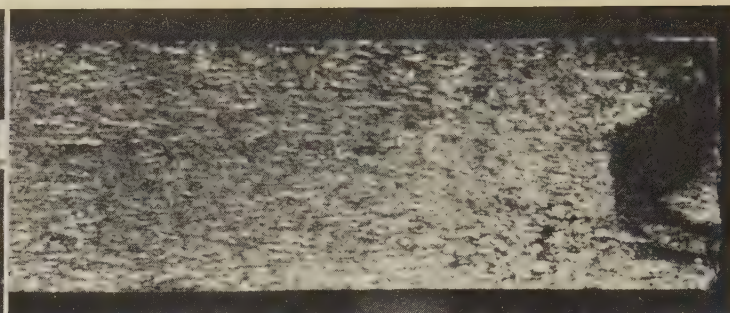
Light fractograph

4078 An enlarged view of the area near "A" in 4077, showing corrosion (in dark area at right end) at the site of crack initiation. The side plate had been used as a fuel-tank support element in a 25-hr ground-level qualification test of the tank in a corrosive environment under spectrum loading. See also 4079.

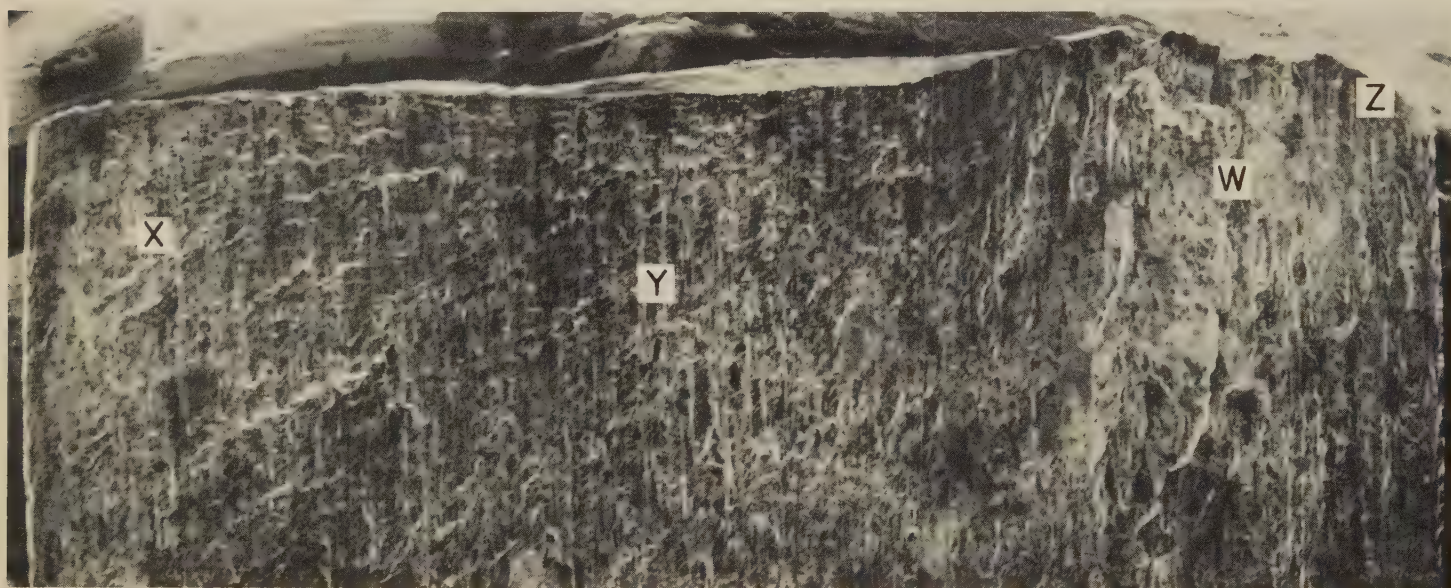
SEM fractograph (composite)

4079 A composite of three low-magnification SEM fractographs of the surface of the fatigue fracture at "A" in 4077 after ultrasonic cleaning. A small portion of the attachment hole is visible along the top of this view. The lack of beach marks here is perhaps due to the brevity of the test (25 hr). Attempts to locate the exact point of crack initiation were not successful, because of the presence of tool marks at the edge of the attachment hole. It is believed, from the orientation of the fatigue striations at "W", "X", "Y" and "Z" (see 4080 to 4083 for enlarged views of these areas), that the crack began at top right, near the edge of the attachment hole.

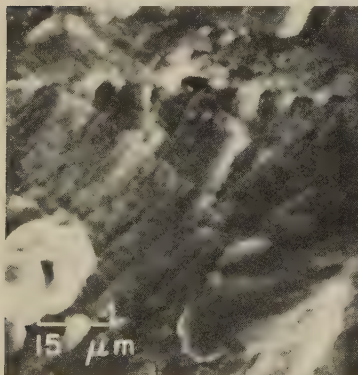
SEM fractograph

4080 Area Z in 4079, which shows clear, well-defined fatigue striations. Normals to the striations point to the crack origin at the nearby corner of the attachment hole.

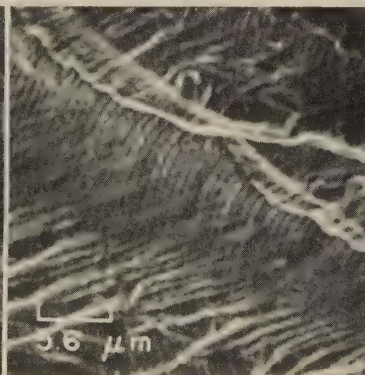
SEM fractograph

4081 Area W in 4079, showing very regular fatigue striations. Like those in 4080, the striations here are oriented so that normals to them point to the corner near area Z.

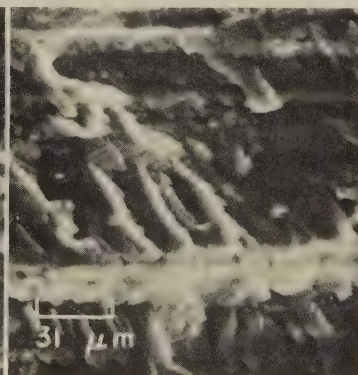
SEM fractograph

4082 Area Y in 4079. This area, which is near the midthickness of the side plate, shows a herringbone pattern with ten times the spacing of the fatigue striations in 4081.

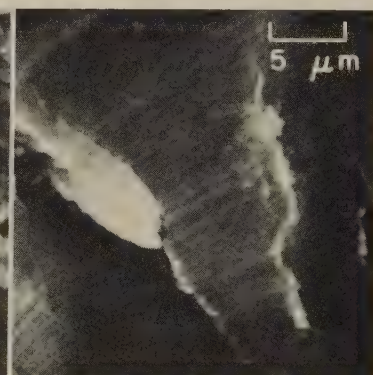
SEM fractograph

4083 View of area X in fractograph 4079. This area, which is near the top left corner of the attachment hole, shows numerous fatigue facets that contain striations.

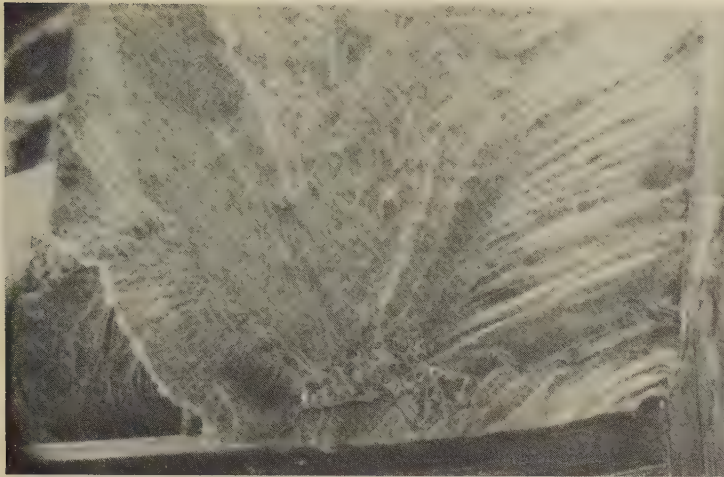
SEM fractograph

4084 Fatigue fracture in a notched plate specimen of aluminum alloy 7075-T6 subjected to cyclic stresses in air. (Notch is at bottom; sides of plate, at far left and right.) It is apparent that the fracture consists of at least three cracks that formed on various planes and temporarily grew independently.

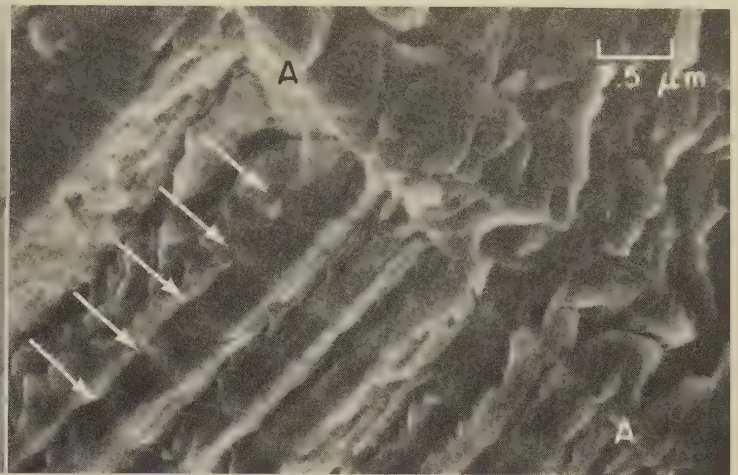
SEM fractograph

4085 Fatigue fracture in a specimen of aluminum alloy 7075-T6 tested in air. The surface exhibits a pattern of brittle, widely spaced striations (at arrows) that are nearly parallel to a grain boundary (A-A). The tensile component (wide, flat region) of each striation was formed by a cleavage mechanism of fracture.

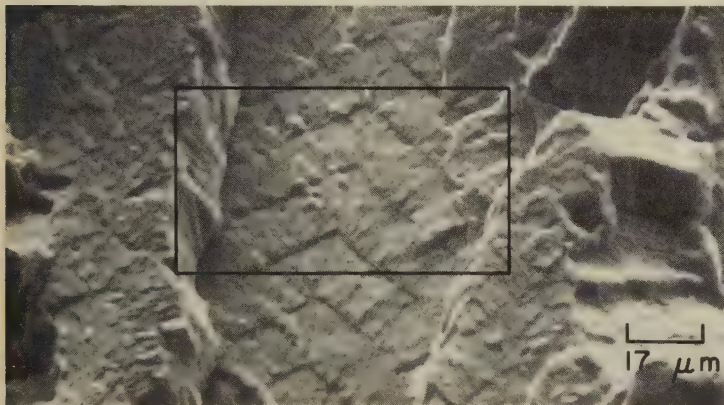
SEM fractograph

4086 Corrosion-fatigue fracture in a specimen of aluminum alloy 7075-T6 tested in distilled water. Surface exhibits fatigue striations. The unusual sharp angle in the striations defines the location of a nearly vertical grain boundary, in the central grain. Area in rectangle is shown at higher magnification in 4087.

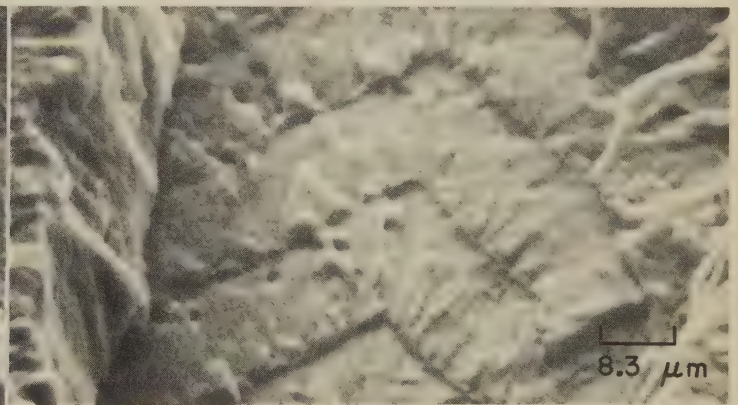
SEM fractograph

4087 A view of the area in the rectangle in 4086, at double the magnification there. Observe the wide, flat regions of the fatigue striations; these regions have progressed by cleavage. The unusual angled shape of the striations is the result of adherence of the crack fronts to crystallographic directions.

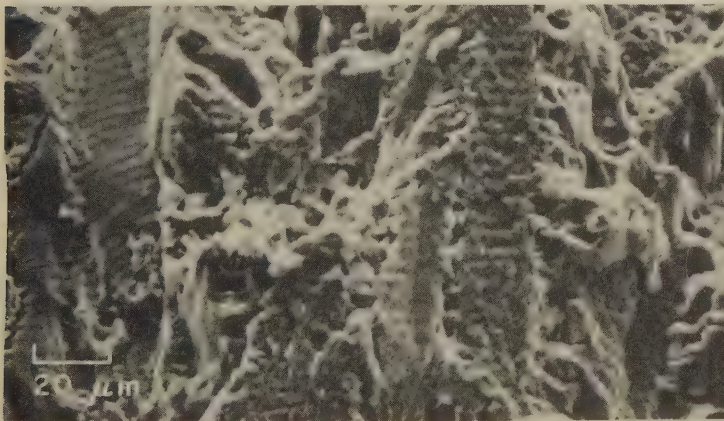
SEM fractograph

4088 Corrosion-fatigue fracture in a specimen of aluminum alloy 7075-T6 that was tested in a 3.5% NaCl solution. Surface shows two types of striations: at left and at lower right are grains with ductile striations, and between them lies a grain with pronounced brittle striations. See also fractograph 4089.

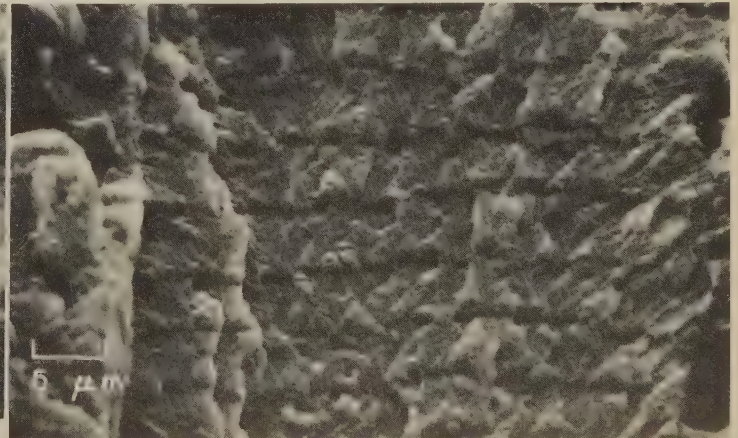
SEM fractograph

4089 Brittle striations in a corrosion-fatigue fracture in a specimen of aluminum alloy 7075-T6 that, like the specimen in 4088, was tested in a 3.5% NaCl solution. Striations (horizontal here) have very uniform spacing.

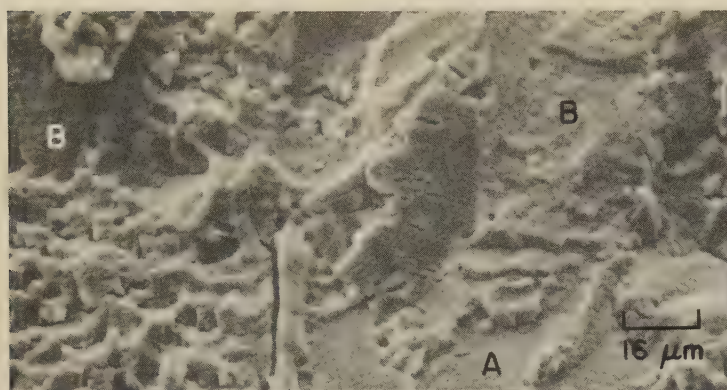
SEM fractograph

4090 Corrosion-fatigue fracture in aluminum alloy 7075-T6 tested in a 3.5% NaCl solution. During testing, specimen was subjected to an applied electrical potential of -0.700 mv as measured against a standard calomel electrode. A mixture of ductile striations (at A) and brittle striations (at B) is evident, with some fissures. See also fractograph 4091.

4091 Corrosion-fatigue fracture in a specimen of aluminum alloy 7075-T6 that was tested in a 3.5% NaCl solution and, during testing, was subjected to an applied electrical potential of -1.200 mv (versus -0.700 mv for specimen in 4090). Surface shows brittle striations that exhibit typical topography; there is no evidence of striation fissures here. See also 4092.

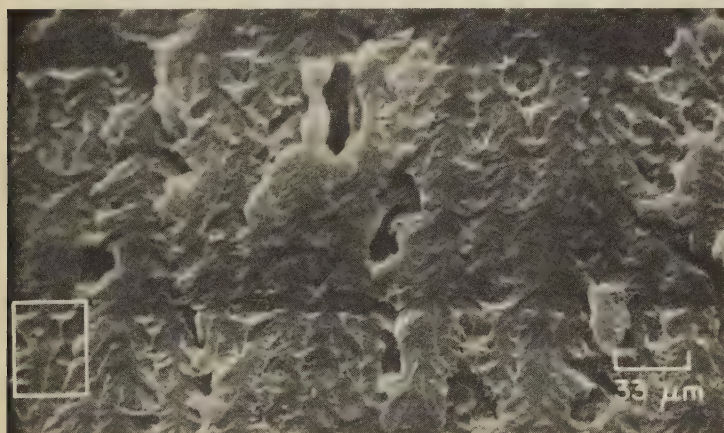
SEM fractograph

4092 Corrosion-fatigue fracture in a specimen of aluminum alloy 7075-T6 that, like the specimen in 4091, was tested in a 3.5% NaCl solution while subjected to an applied electrical potential of -1.200 mv. Note the extremely large striation spacing; only two readily apparent adjacent brittle-striation peaks are included in this view. See also fractograph 4093, at right.

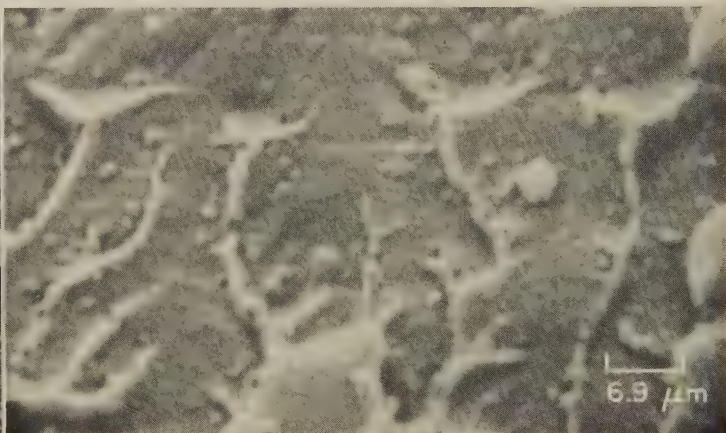
SEM fractograph

4093 A higher-magnification view of the fracture in 4092, showing an area of which the right half is outlined by the rectangle there. The wide, flat portion of a single striation is visible, beginning at the peak near the top. The surface configuration in this region of cleavage separation suggests a set of river patterns, exaggerated by corrosion products.

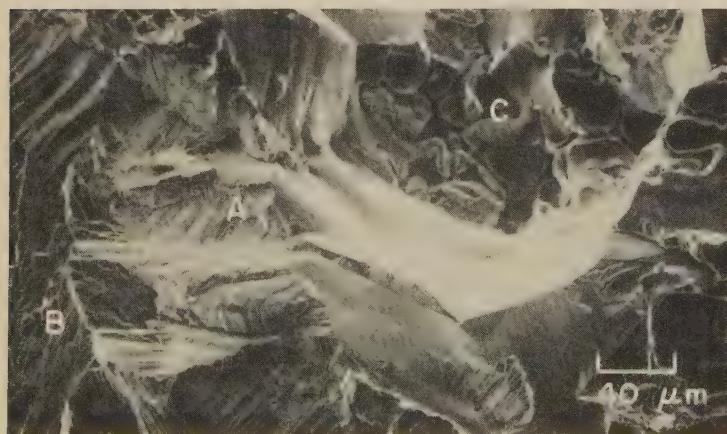
SEM fractograph

4094 Fatigue-fracture surface of a test bar cast from aluminum alloy 7075, aged to the T6 temper and then tested in a 3.5% NaCl solution. A diagonal region of fatigue striations is visible at A; this region abuts areas of intergranular fracture (at B) and interdendritic porosity (at C).

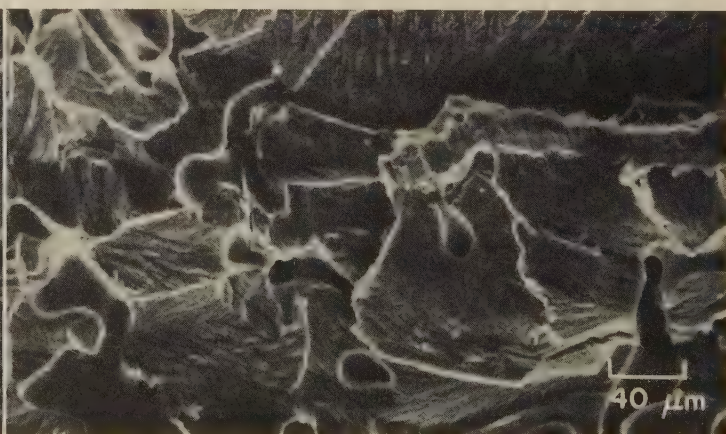
SEM fractograph

4095 Fatigue fracture in a cast single-crystal specimen of aluminum alloy 7075 that was aged to the T6 temper and then tested in a 3.5% NaCl solution. Most of the view is filled with an interdendritic network of solidification porosity, which did not halt or blunt the fatigue crack.

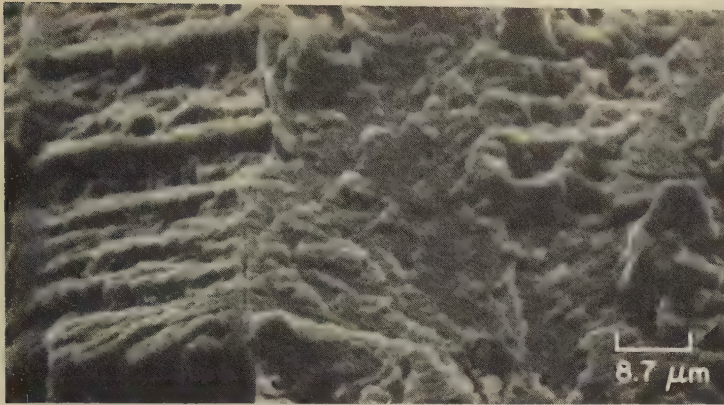
SEM fractograph

4096 Surface of a corrosion-fatigue fracture in a specimen of aluminum alloy 7075-T6 that was tested in a 3.5% NaCl solution. Shown here are portions of two grains that exhibit brittle striations; the difference in appearance of the striations in the two grains is caused by the difference in grain orientation. The vertical dividing line is the boundary between the grains.

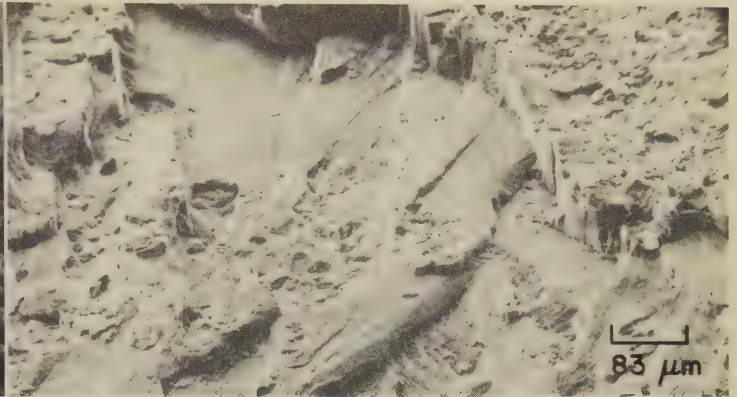
SEM fractograph

4097 An area of the corrosion-fatigue fracture surface of an aluminum alloy 7075-T651 specimen that was tested in a 3.5% NaCl solution under a cyclic stress-intensity range (ΔK) of 6.6 MPa·m^{1/2} (6 ksi·in.^{1/2}) at 10 cycles per second. Ductile and brittle striations would be expected in such a fracture but cannot be resolved at this magnification. See also fractograph 4098.

4098 Another area of the fracture surface of which a portion is shown in 4097. This possesses similar features, but the surface is flatter, lacking the bluflike cleavage steps present in 4097. Again, fatigue striations are unresolved. See 4099.

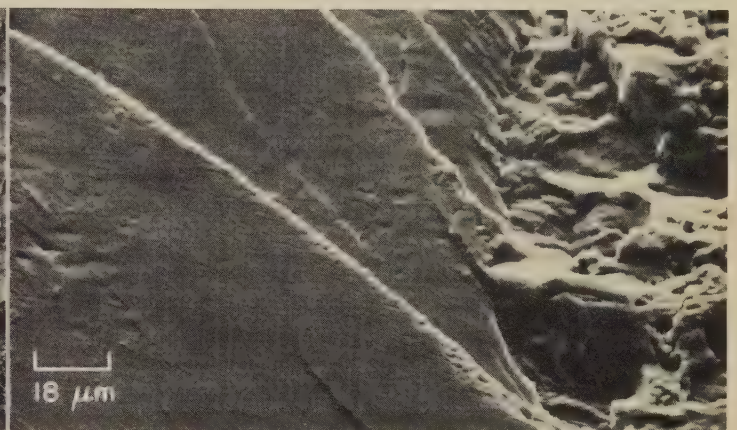
560×

4099 Area in the rectangle in 4098, at higher magnification, showing the edge of the smooth area believed to possess patches of ductile striations. Compare these features with those of the 7475-T6 specimen (also tested in 3.5% NaCl) in 4100, 4101.

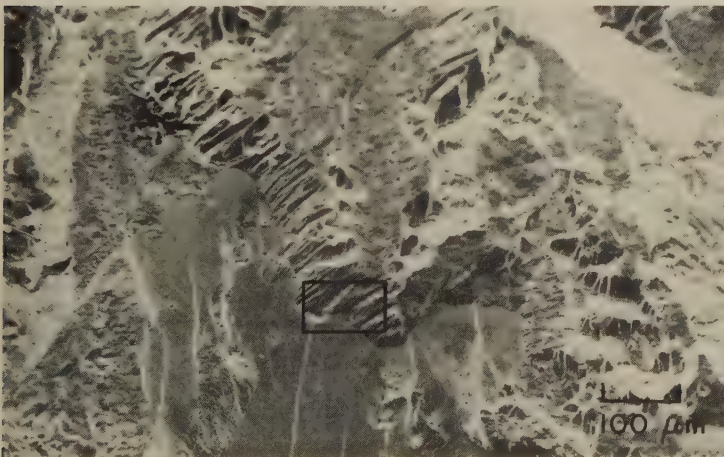
100×

4100 Corrosion-fatigue fracture in aluminum alloy 7475-T6 tested in a 3.5% NaCl solution under a cyclic stress-intensity range (ΔK) of 13 MPa·m^{1/2} (12 ksi·in.^{1/2}) at 10 cycles per second, showing contrasting features: ductile striations (unresolved) in smooth regions; brittle striations in adjacent grains. See 4101.

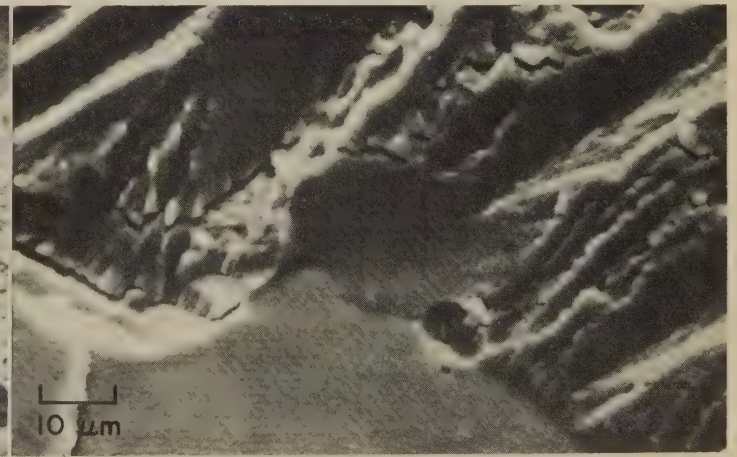
1000×

4101 Area outlined by the rectangle in fractograph 4100, as seen at ten times the magnification there, which makes the fine fatigue striations in the smooth region clearly visible. Above are brittle striations forming, at a steep incline, what is in effect a cleavage step up to a second fracture level.

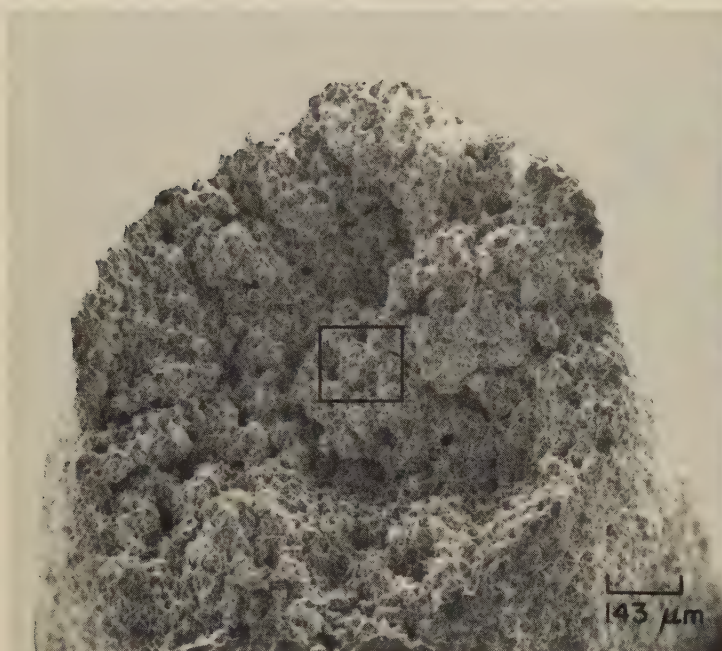
70×

4102 Tensile-overload fracture in a specimen of a superplastic eutectic alloy containing 67% Al and 33% Cu. The material was cast, and the as-cast ingot was extruded at 430 C (806 F). Testing was performed at 0.001 in. per second and at a controlled temperature of 450 C (842 F). The surface shows coarse dimples and an irregular contour. There is some suggestion of a shear lip, but it is not sharply defined. See also 4103 (right).

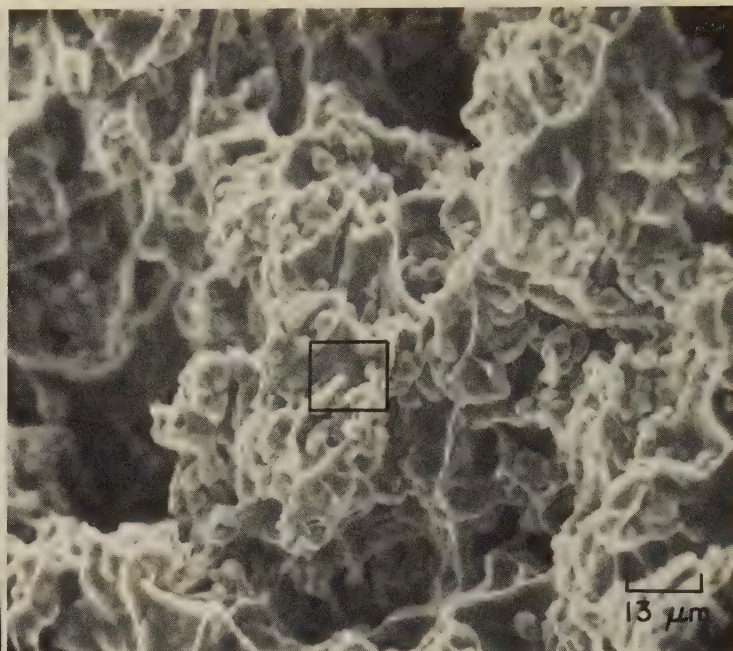
770×

4103 A higher-magnification view of the area in the rectangle in fractograph 4102 (left), showing more clearly the details of the fracture surface. It should be noted that the grain size of this specimen is approximately 7 μm. Note also that a majority of the dimples contain one or more particles — probably particles of the CuAl₂ phase of the eutectic. See 4106 (opposite page), a higher-magnification view of area in rectangle here.

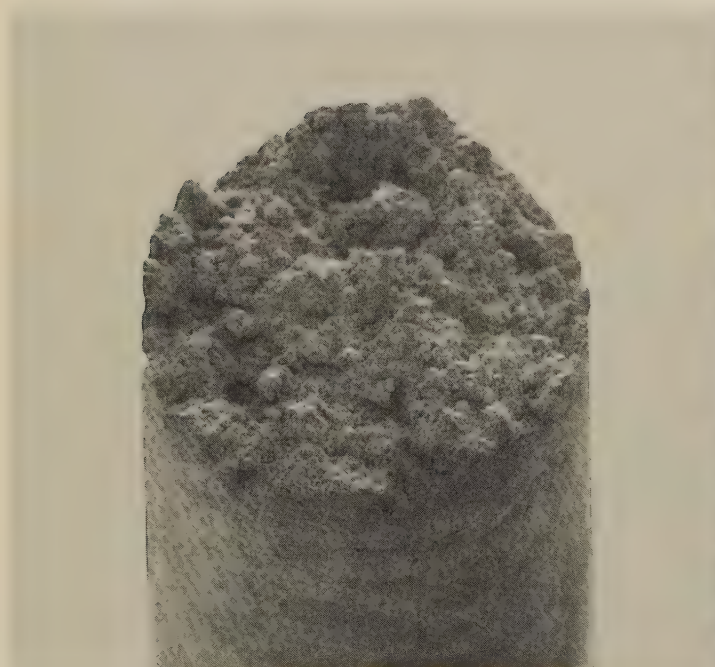
26×

4104 Surface of a tensile-overload fracture in a specimen of 67Al-33Cu superplastic eutectic alloy that was cast, extruded and tested exactly the same as the specimen in fractograph 4102 (above). The grain size of this specimen is 10 μm, compared with 7 μm for the specimen in 4102. The fracture surface shown here is fully as rough as that in 4102, but here there is no suggestion of a shear lip. See also fractograph 4105 (right).

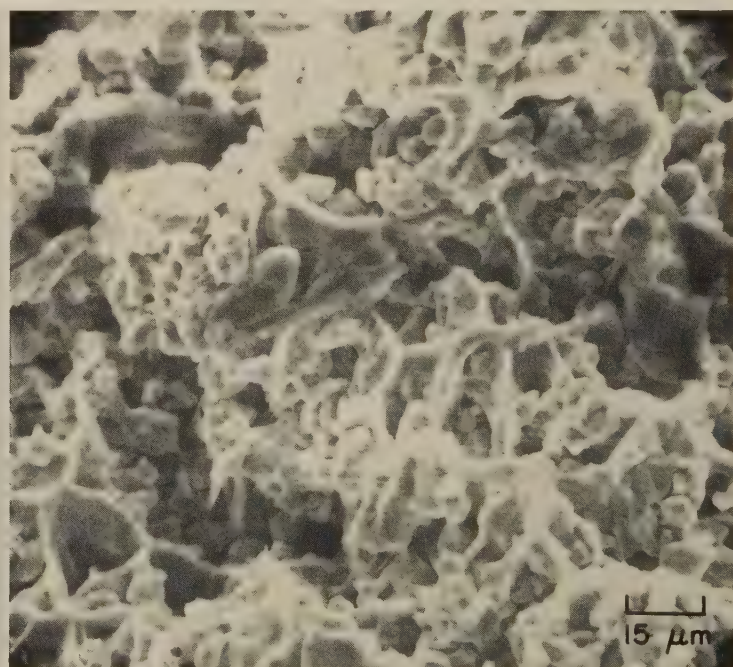
670×

4105 View of a region at the center of the fracture surface in 4104, shown at higher magnification. The dimples contain particles of the CuAl₂ phase of the eutectic that are similar in size and, for the most part, in contour to those in 4103. There does not appear to be much adherence of these particles to the matrix. The difference in grain size here and in 4103 is not apparent because of the difference in magnification. See also 4108.

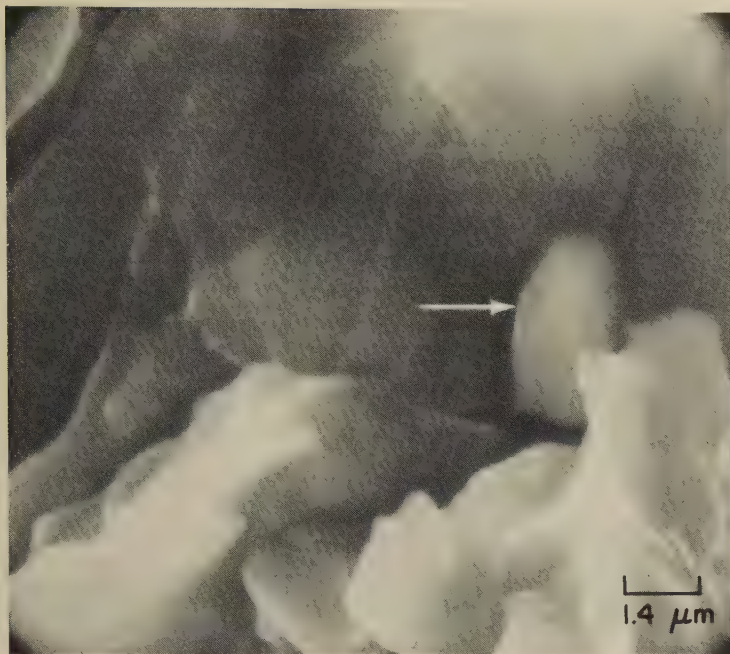
7000×

4106 Higher-magnification view of the area in the rectangle in fractograph 4103 (opposite page, top row). The contours of the facets in the right foreground demonstrate that the aluminum solid-solution matrix phase of this eutectic alloy was highly ductile. In the right background, at arrow, is a spheroidal particle that should be of the CuAl_2 phase; most of the surface of this particle appears to be detached from the matrix.

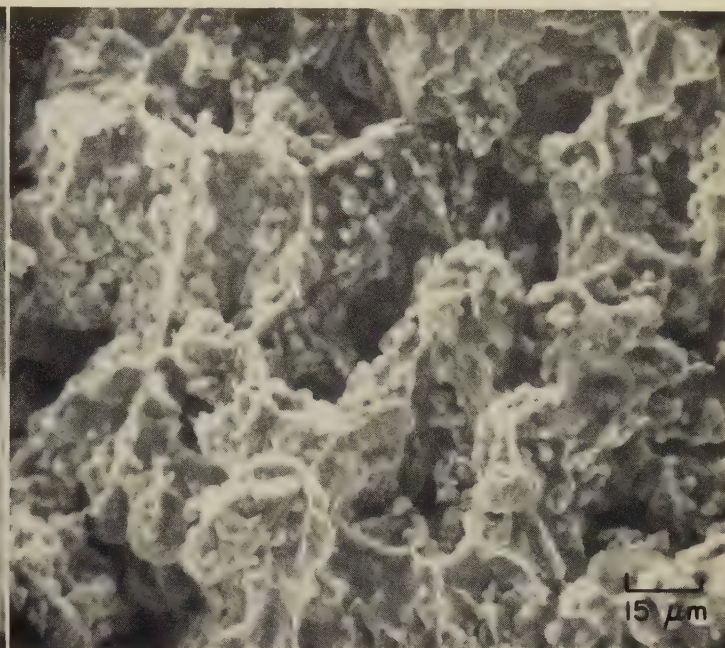
670×

4107 Tensile-overload fracture in a specimen of 67Al-33Cu alloy that was cast, extruded and tested the same as the specimens in 4102 and 4104. In this specimen, the grain size is only 2 μm . It appears that both the large dimples and the CuAl_2 particles here are smaller than those in 4103 and 4105, but certainly greater than one-fifth the size of those in 4105, which shows a specimen with a grain size of 10 μm .

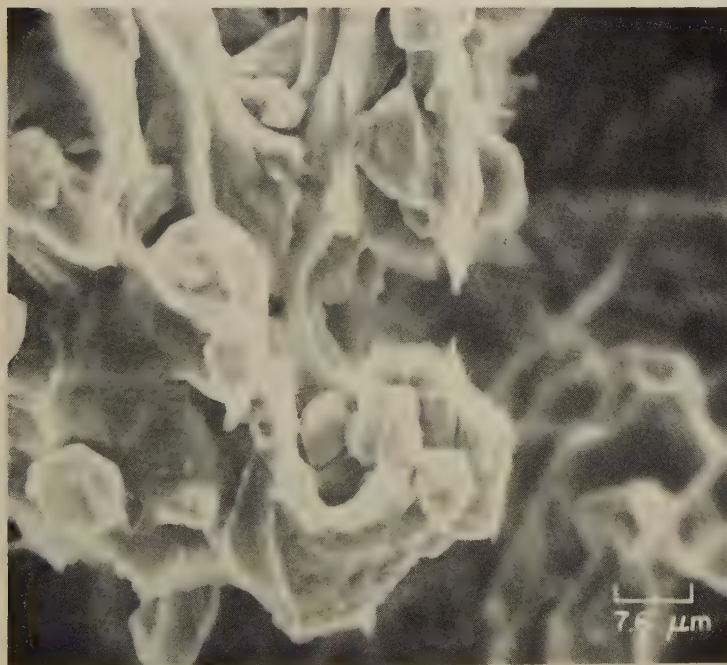
1320×

4108 A view of the fracture surface in 4104 (opposite page, bottom row), showing a different area than in 4105, at a still-higher magnification. Note that the aluminum solid-solution matrix phase has undergone a high degree of plastic flow, deforming into many fine points and spicules. Adjacent regions of the fracture surface would be expected to contain some of the very smooth facets that are formed by stretching.

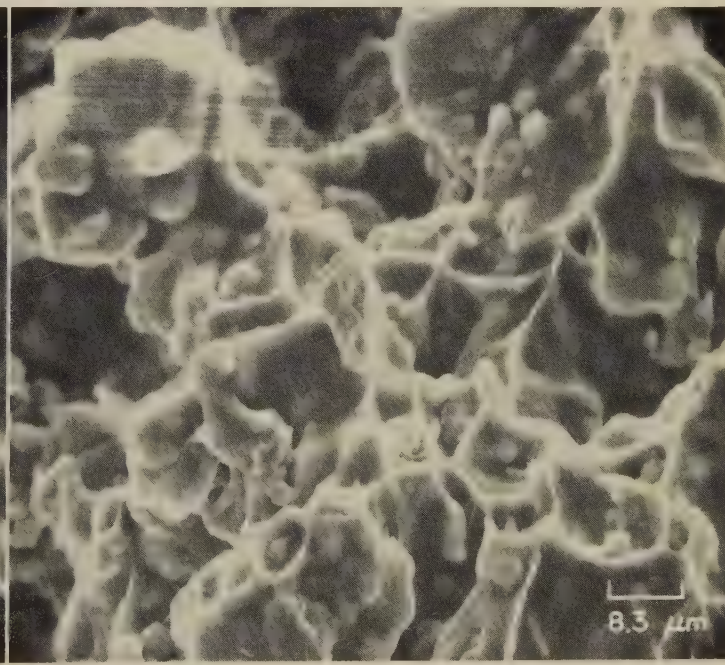
1200×

4109 Tensile-overload fracture in a specimen of 67Al-33Cu alloy that was cast, extruded and tested the same as those in 4102, 4104 and 4107; the grain size of this specimen is 5 μm . Compared with 4108 (grain size, 10 μm), this specimen has smaller CuAl_2 particles, about the same degree of plastic flow of the aluminum solid-solution matrix phase, and more complete bonding of many of the particles of CuAl_2 phase to the matrix.

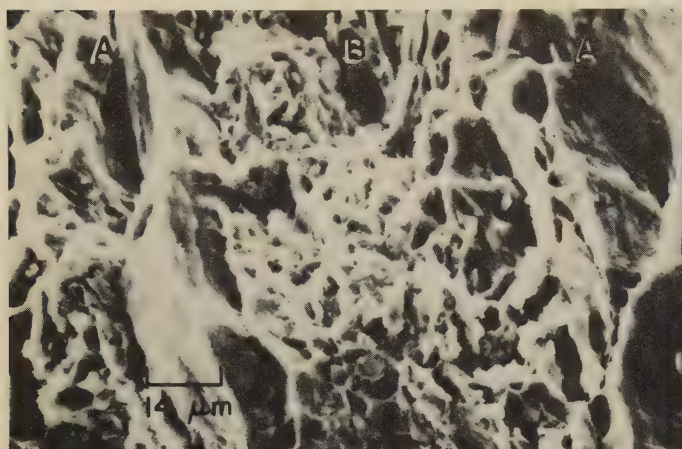
725×

4110 Typical transverse tensile fracture in the aluminum matrix material used in preparing boron-aluminum composites. View shows two layers of aluminum alloy foil (locations A) that were plasma-arc sprayed with aluminum alloy powder (location B) then hot-press bonded.

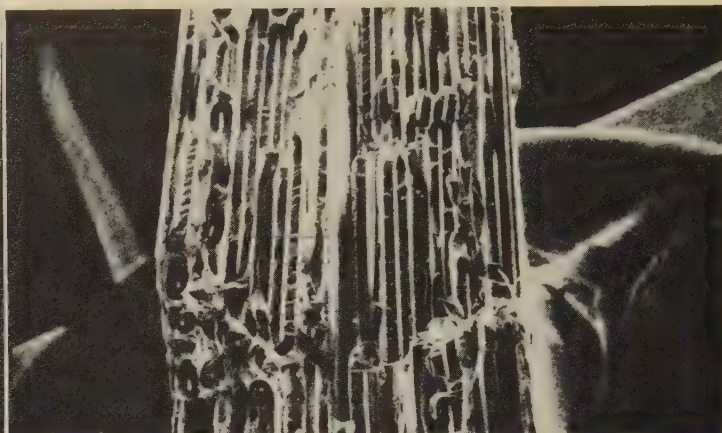
37 1/2×

4111 Surface of a transverse tensile fracture in a sheet of composite consisting of 4.2-mil-diam BORSIC fibers (boron filaments formed by vapor deposition on tungsten cores, then vapor coated with silicon carbide) in a matrix of aluminum alloy 6061 (foil and sprayed powder). The fibers split longitudinally on a diametral plane. See also 4112.

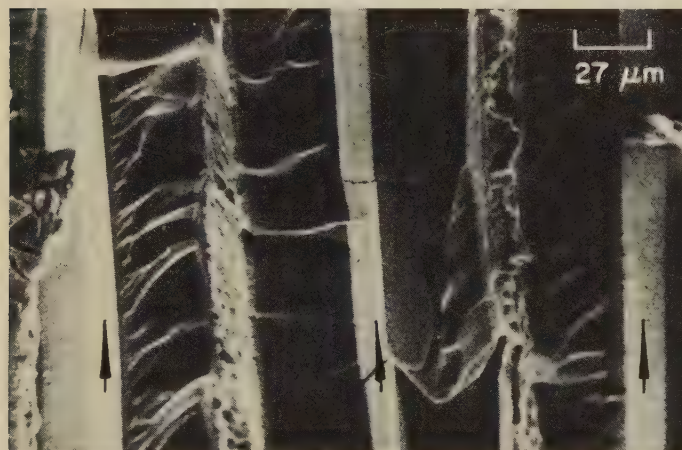
375×

4112 Transverse tensile fracture in a sheet of BORSIC-aluminum composite, similar to 4111, but at higher magnification. The aluminum alloy 6061 matrix is indicated by the arrows. At the center of each 4.2-mil-diam BORSIC fiber is its tungsten core. Fracture of the fibers originated at flaws in the fiber surfaces.

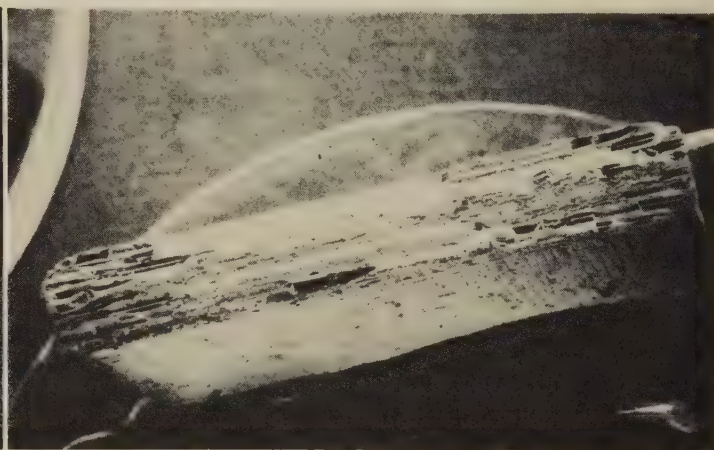
11×

4113 Transverse tensile fracture in a sheet of BORSIC-aluminum composite. The BORSIC fibers are 4.2 mils in diameter; the matrix is foils of aluminum alloy 1145 plasma-arc sprayed with aluminum alloy 1100 powder. Few of the fibers have split, except where specimen edges were damaged during preparation.
